PIPER ALPHA OIL PLATFORM

Blast blamed on compression chamber leak

By Roger Highfield, Technology Correspondent

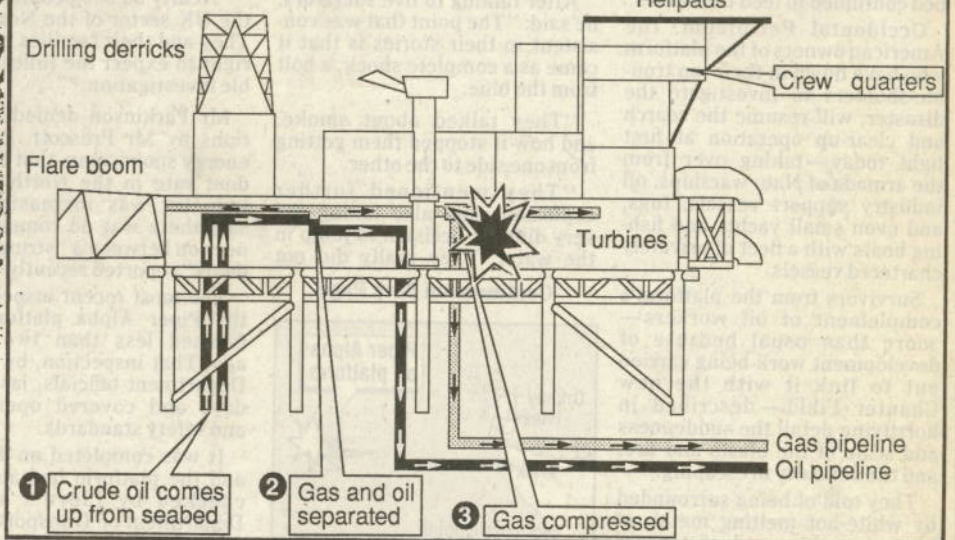
WHERE EXPLOSION STARTED

THE CAUSE of the explosion that ripped the Piper Alpha platform apart was probably a leak of gas into the platform's 'C' module, the chamber where gas is compressed (see number 3 on diagram above) before it is transmitted down a major pipeline, Occidental Petroleum said last night.

It would appear that the first explosion occurred because of a leak of gas in the compression module.
