PIPER ALPHA OIL PLATFORM

Blast blamed on compression chamber leak

By Roger Highfield, Technology Correspondent

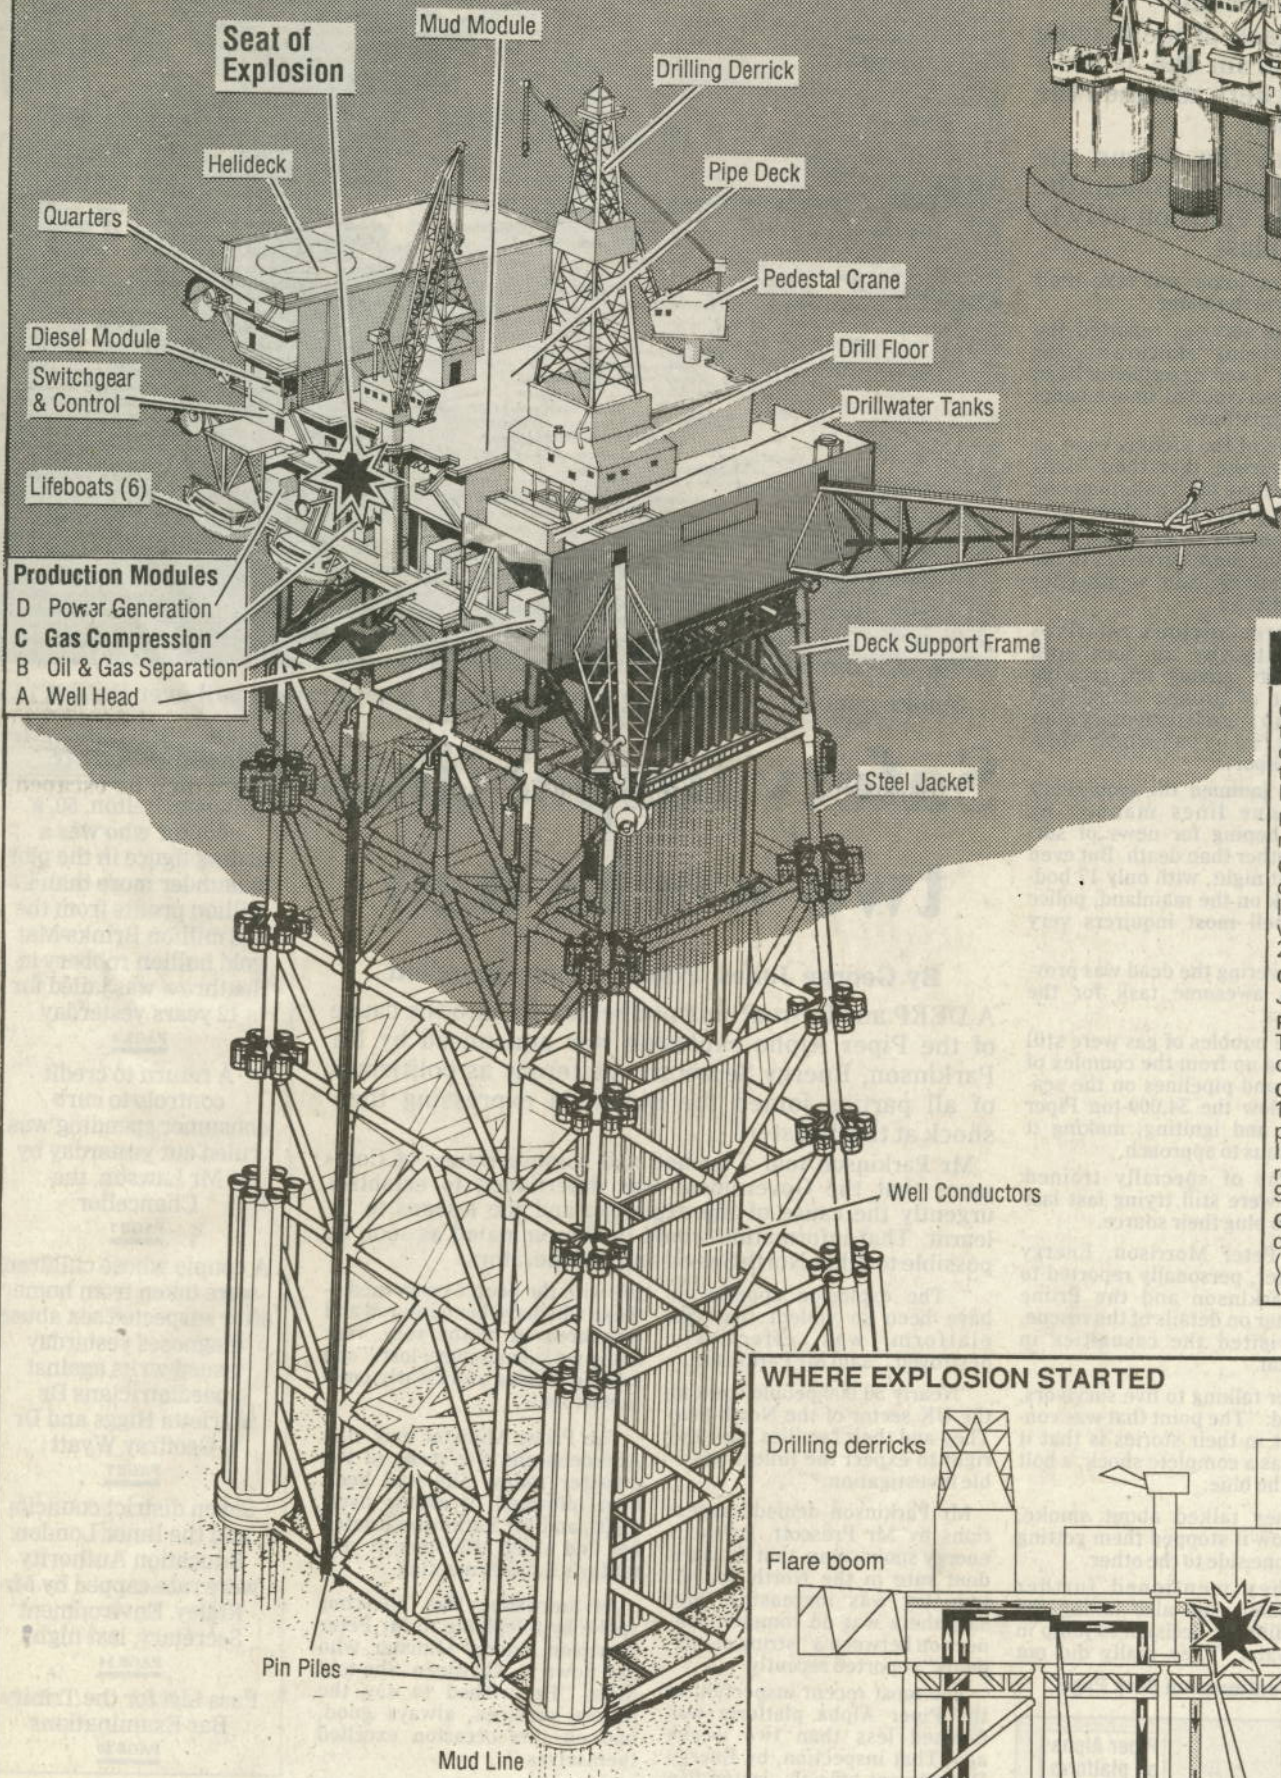
Owners: Occidental North Sea Consortium, formed in 1971, comprising Occidental Petroleum, Getty Oil, International Thomson and Union Texas Petroleum

Field discovered January 1973, 120 miles north-east of Aberdeen

Construction: Designed by Bechtel Ltd of London and built in Ardersier, Scotland, and Le Havre, France. Platform weighs 34,000 tonnes and stands nearly 200 ft above sea level in 474 ft of water

Oil production: began in December 1976; now estimated at 167,200 barrels per day, piped via 30 in pipeline to Flotta Island terminal in Orkney. Ultimate recoverable oil reserves estimated at 963 million barrels

Gas production: 23 million cubic feet per day; mainly methane (81%), ethane (12%), nitrogen and carbon dioxide (5%) and propane (2%)
